Seymour River Rockslide Mitigation

**Seymour Salmonid Society
PO Box 52221
North Vancouver, BC
V7J 3V5**

**Final Report
January 4, 2015**

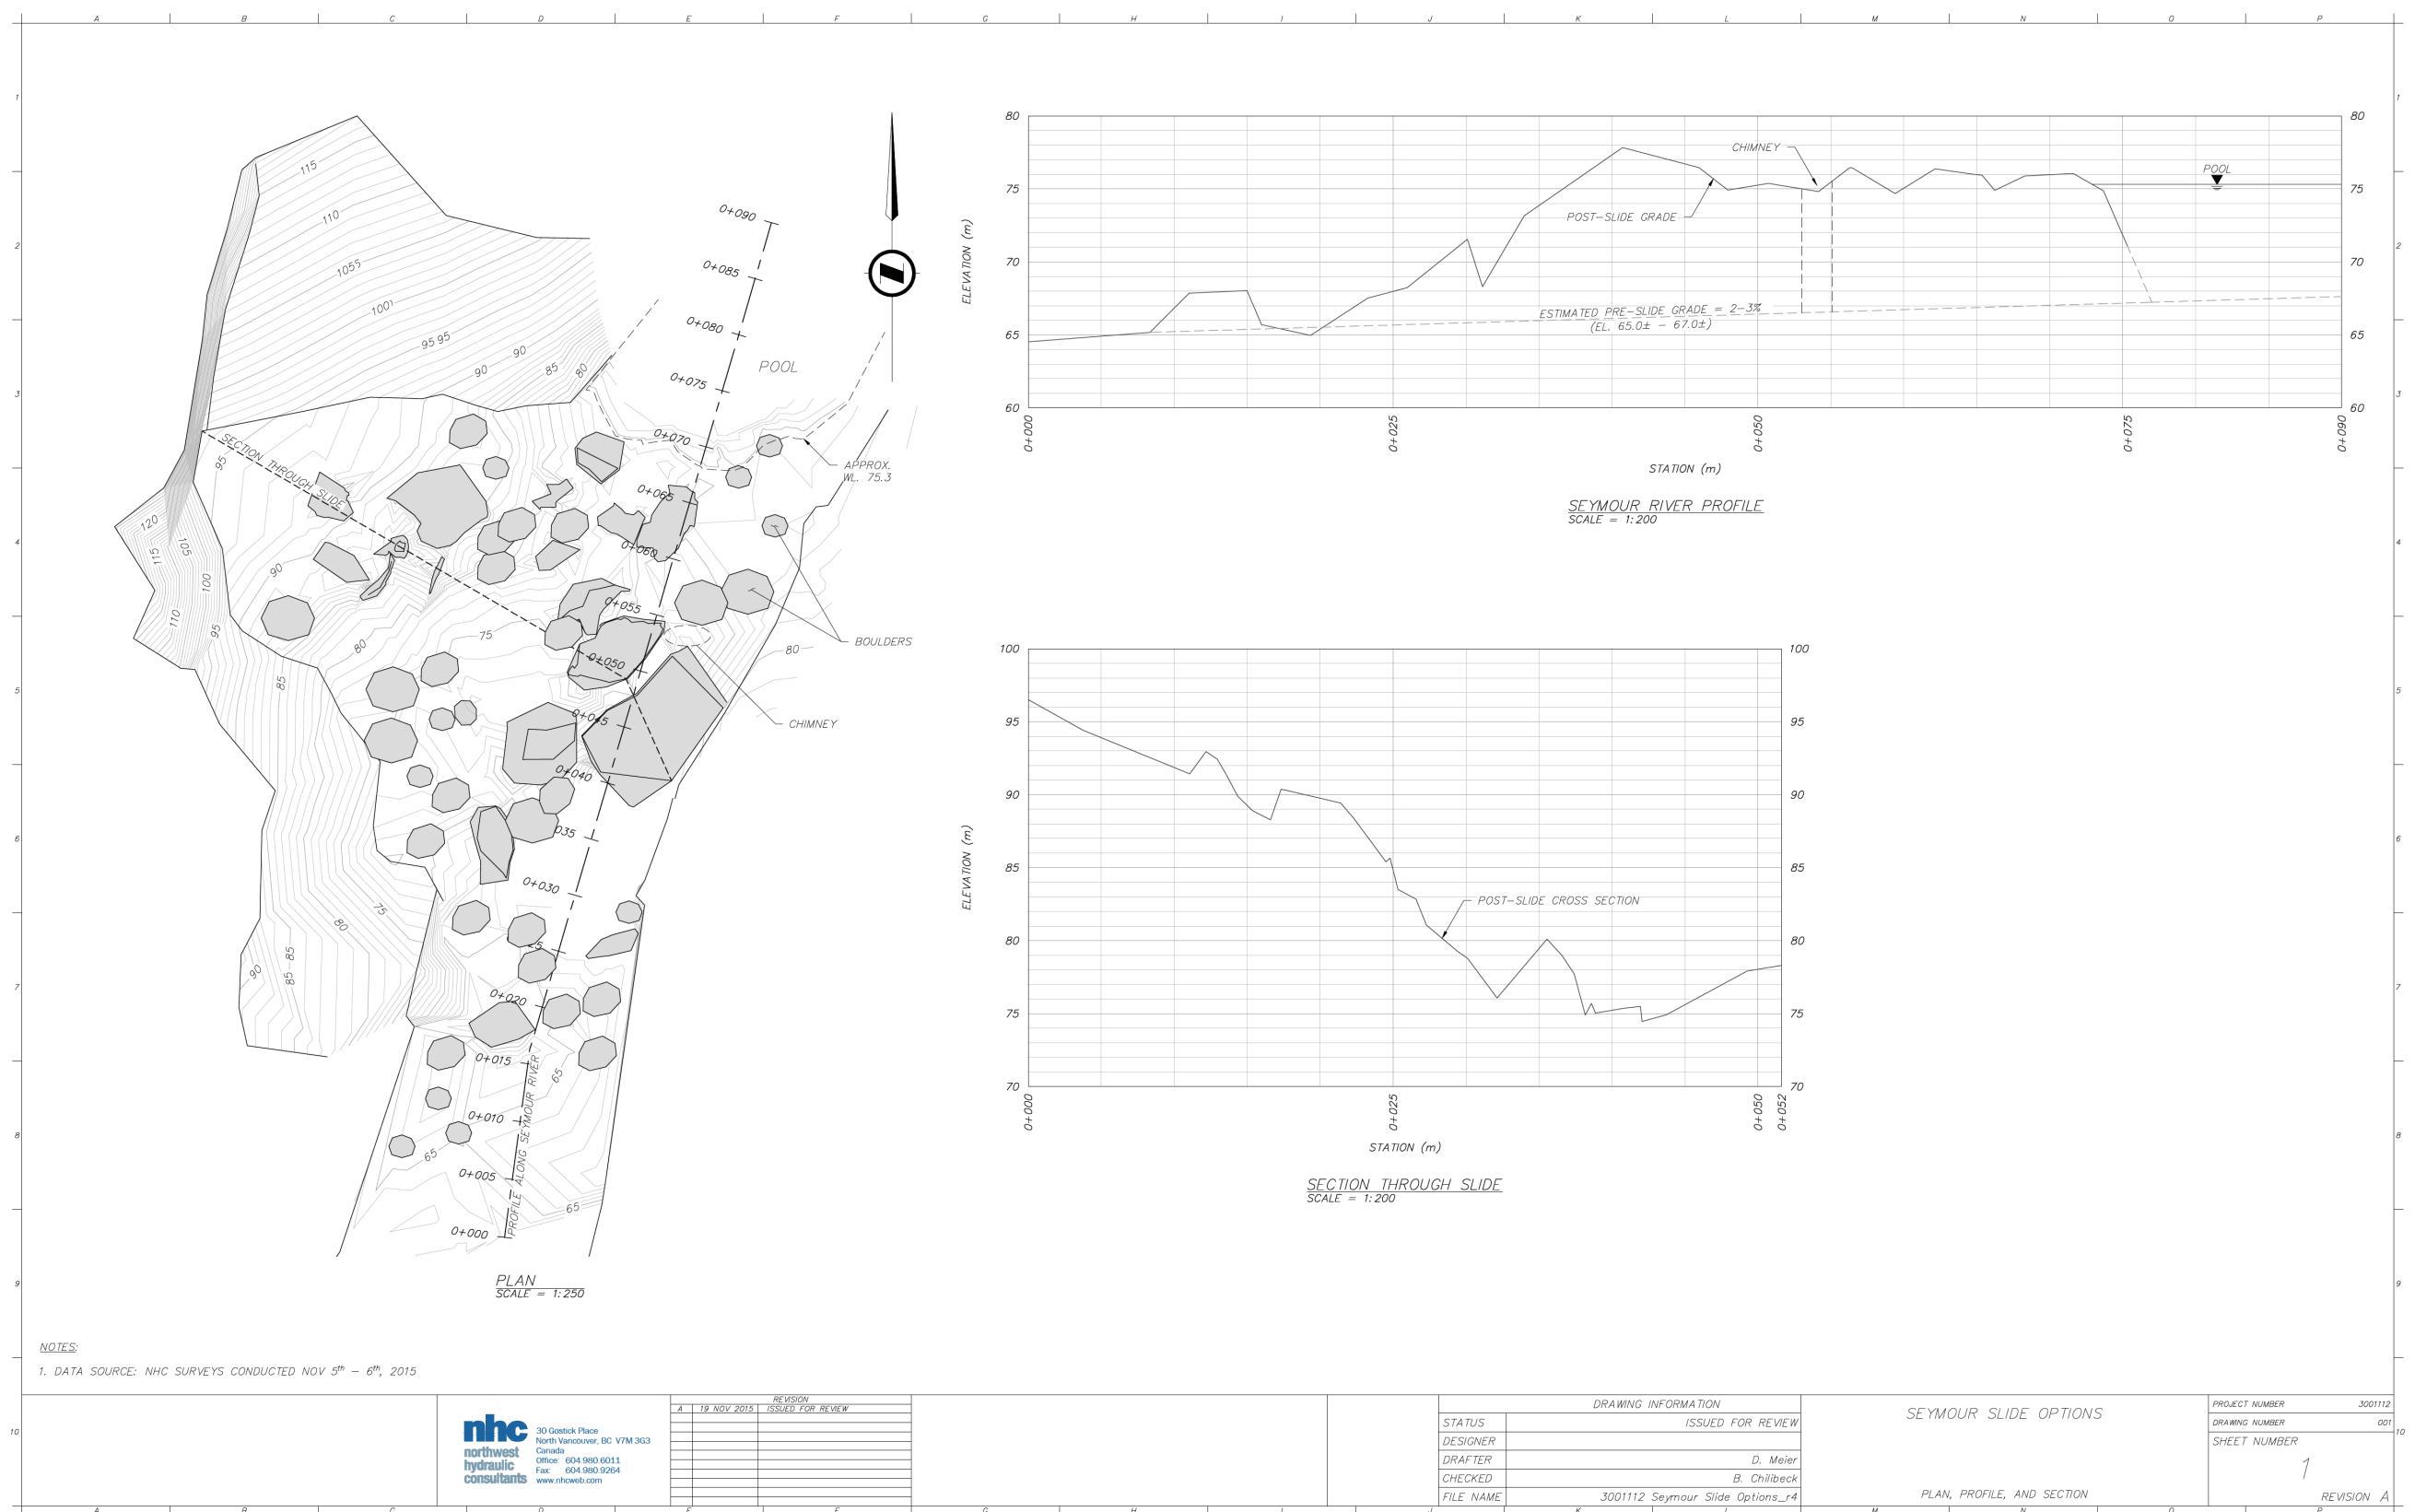
Figure 2 NHC Rockslide Survey.

At the slide, the primary physical barrier is a 7 m high “chimney” under a primary approximately 1,000 m³ boulder (Sta. 0+55 Profile Section, **Figure 2**). At lower flows (less than 4 m³/s) there is a hydraulic disconnection as the flows seep through the porous dam crest. At flows exceeding 4 m³/s, the river spills over the crest and downstream underneath this boulder chimney. At these intermediate flows, fish cannot access nor ascend the chimney and may be sustaining damage attempting passage. As flows further increase, the hydraulic capacity of the chimney is exceeded and flows spill over the top of the large boulder and overtop the entire slide. At these high flows the hydraulics are extreme and highly aerated with excessive velocities preventing fish passage.

Larger boulders were surveyed and are shown on a plan (**Figure 2**). The previous level of the river invert and slope were estimated from the new survey data and existing pre-rock slide LiDAR data.

The December 2014 rock slide debris formed a deposit that extends approximately 15 m above the existing canyon floor, and is comprised of boulders up to about 12 m maximum length, and an estimated average boulder diameter of 3 m to 5 m. Within the canyon, the rock slide deposit in the direction of the river flow is trapezoidal. The upstream face of the deposit is approximately 10 m high (above the existing stream channel elevation), about 30 m wide, and visible debris extends at least 70 m in length in the direction of river flow.

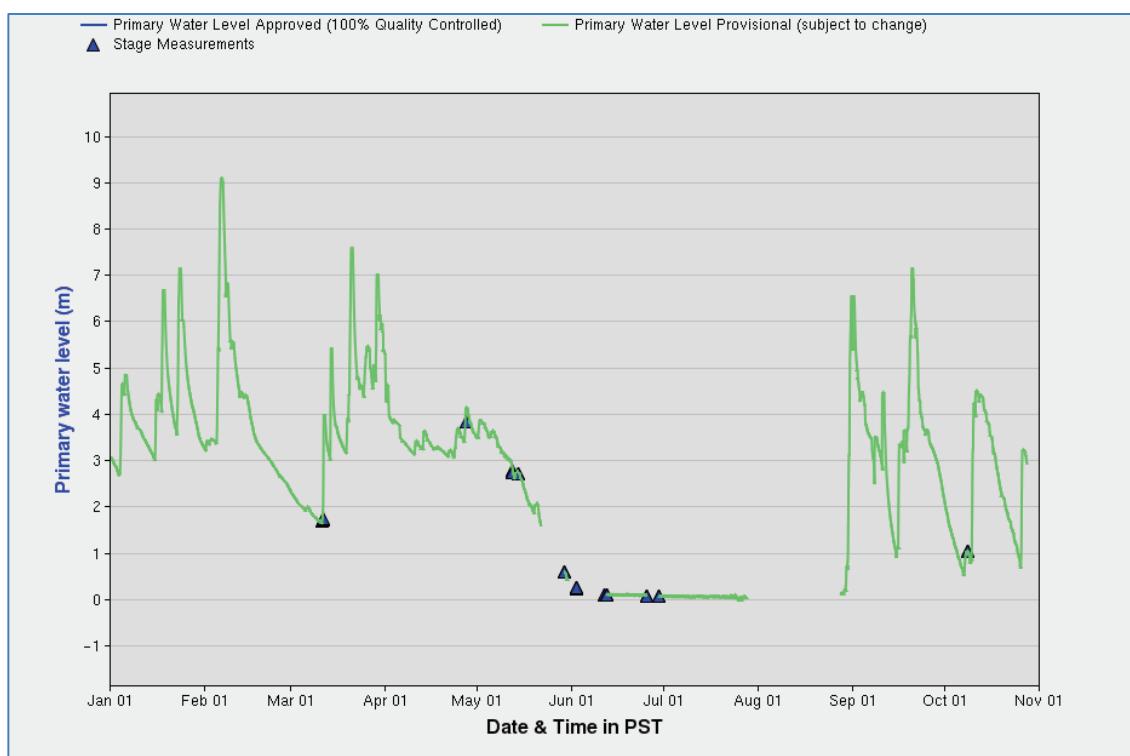
Figure 3 WSC 08GA030 Seymour River water level at Twin Bridges January 1st to October 25th 2015.

Some limited monitoring is ongoing. Water Survey Canada (WSC) has re-installed a temporary hydrometric station on the upstream pool at Twin Bridges, and NHC continues to monitor Seymour River flows via a gauge at Grantham Bridge downstream of the slide. Metro Vancouver monitors flows and water levels upstream of the rock slide at Spur 4 and the Seymour Falls Dam. WSC data from the Twin Bridges site indicates that flows in the Seymour River have resulted in several “high water” events at the slide. This is largely due to the restricted slide crest width and hydraulic effect. In the past 11 months, 10 discrete river flow events in excess of 100 m³/s have occurred (**Figure 3**).

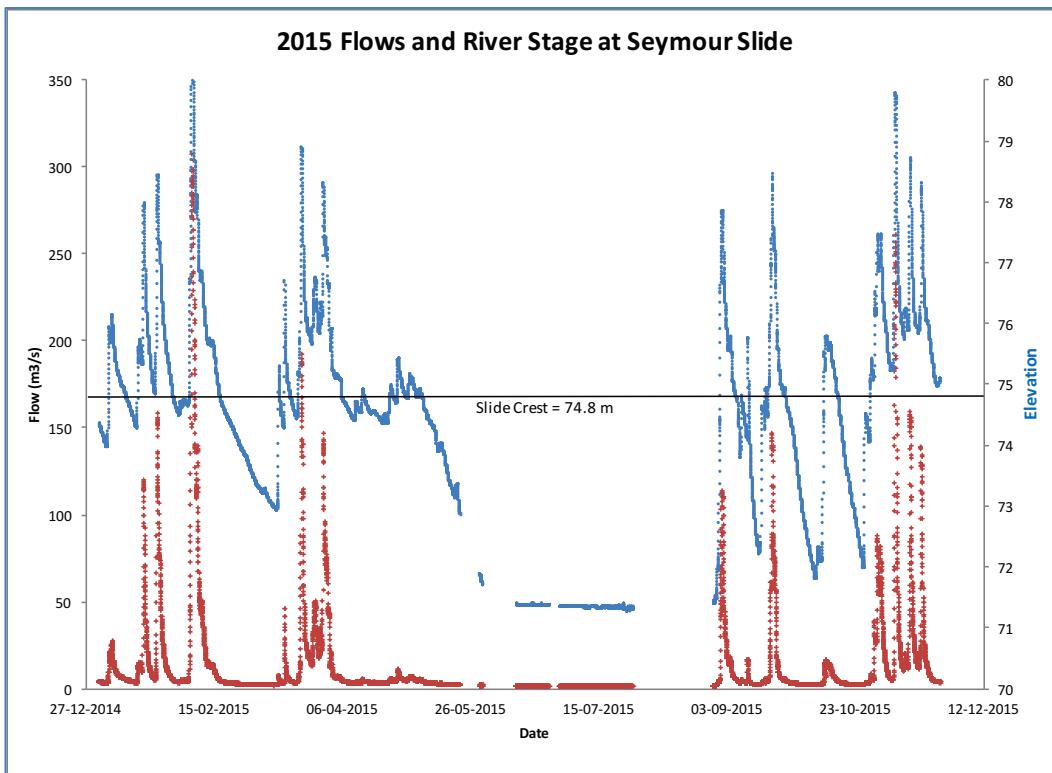
Figure 4 Seymour River Flows and Upstream Water Levels January 1st to November 25th 2015.

Corrected geodetic survey data from the slide was compared to upstream water levels to estimate geodetic water surface elevations and flows at the slide in 2015 (**Figure 4**). With this data the crest elevation was compared to discharge to identify at what discharge the slide would overtop – recognizing that flows through the slide occurred and at low flows water elevations upstream dropped below the crest of the slide. Based on a crest elevation of 74.8 m, a flow of 3.5 m³/s appears to be the cresting flow of the slide.

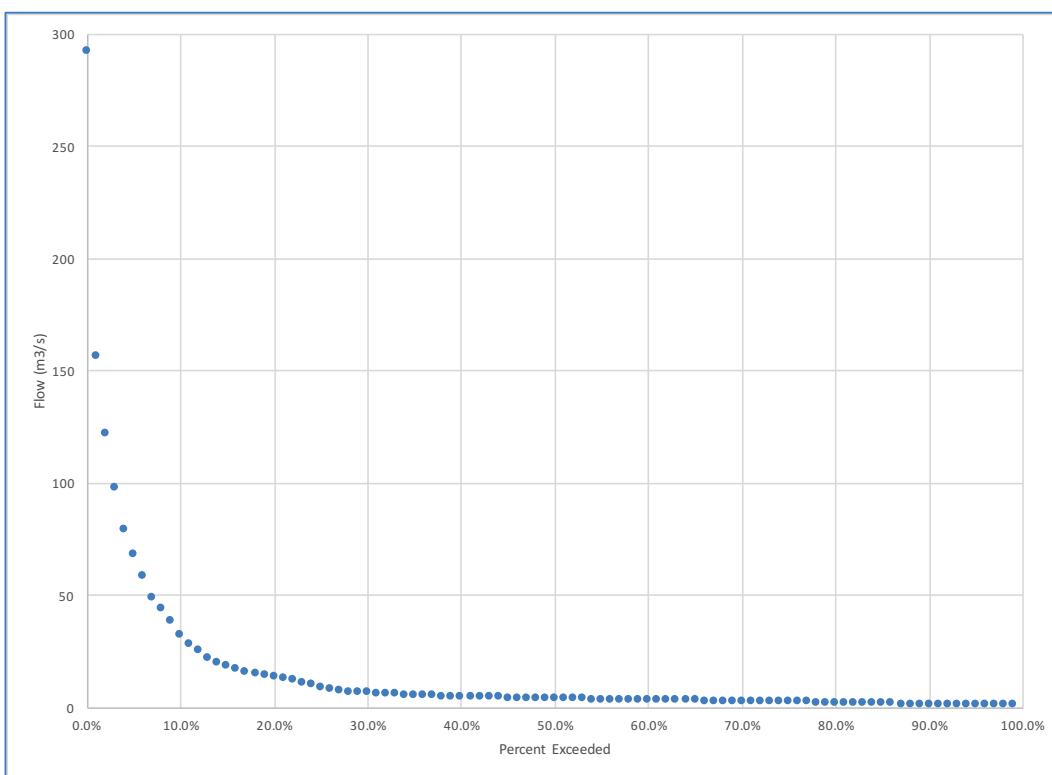
Figure 5 Frequency Distribution of 2015 Seymour River Flows January 1st to November 25th 2015.

Frequency distribution of daily flows at the slide location indicates that the median flow was approximately 3.8 m³/s and the mean was 13.8 m³/s for 2015 (**Figure 5**). Flows exceeding 100 m³/s occur approximately 4% of the time, which concurs roughly with the 10 exceedance flood events on the hydrograph.

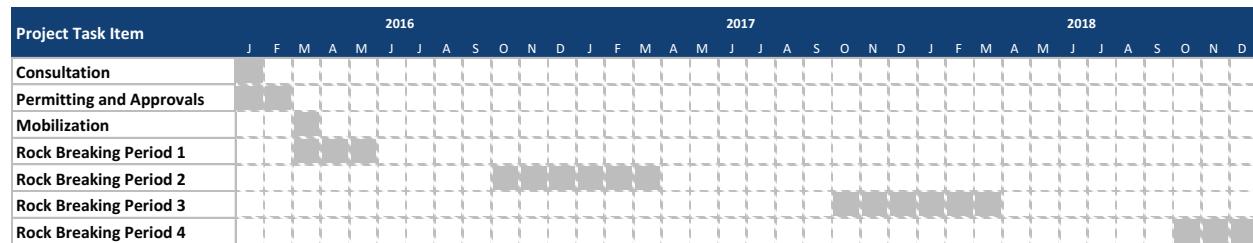
Figure 6 Project Schedule

Based on assessment of the volume of slide debris and productivity of the rock-breaking and scaling, the reshaping process could take 2 to 5 years to complete – or a total of 20 to 40 “work events”. These work events would consist of 3 to 7 day periods when the scaling crew would drill and break rock in preparation for a large flood event. Mobilization for the work is expected to take a week, and could be initiated in early 2016, pending approvals and permitting as required. Remobilization for subsequent cycles of rock breakage, as needed, would have a lower mobilization time.

Assuming that sizable flows will be required to move large boulders created during the scaling operations, approximately 6 to 10 suitable instream low flow work opportunities are likely available in a 12-month period. These low flow periods occur between large floods during the fall to spring period when rainfall and rain-on-snow generate large flows.
