Shovelnose Creek Off-Channel Complex Berm Repair

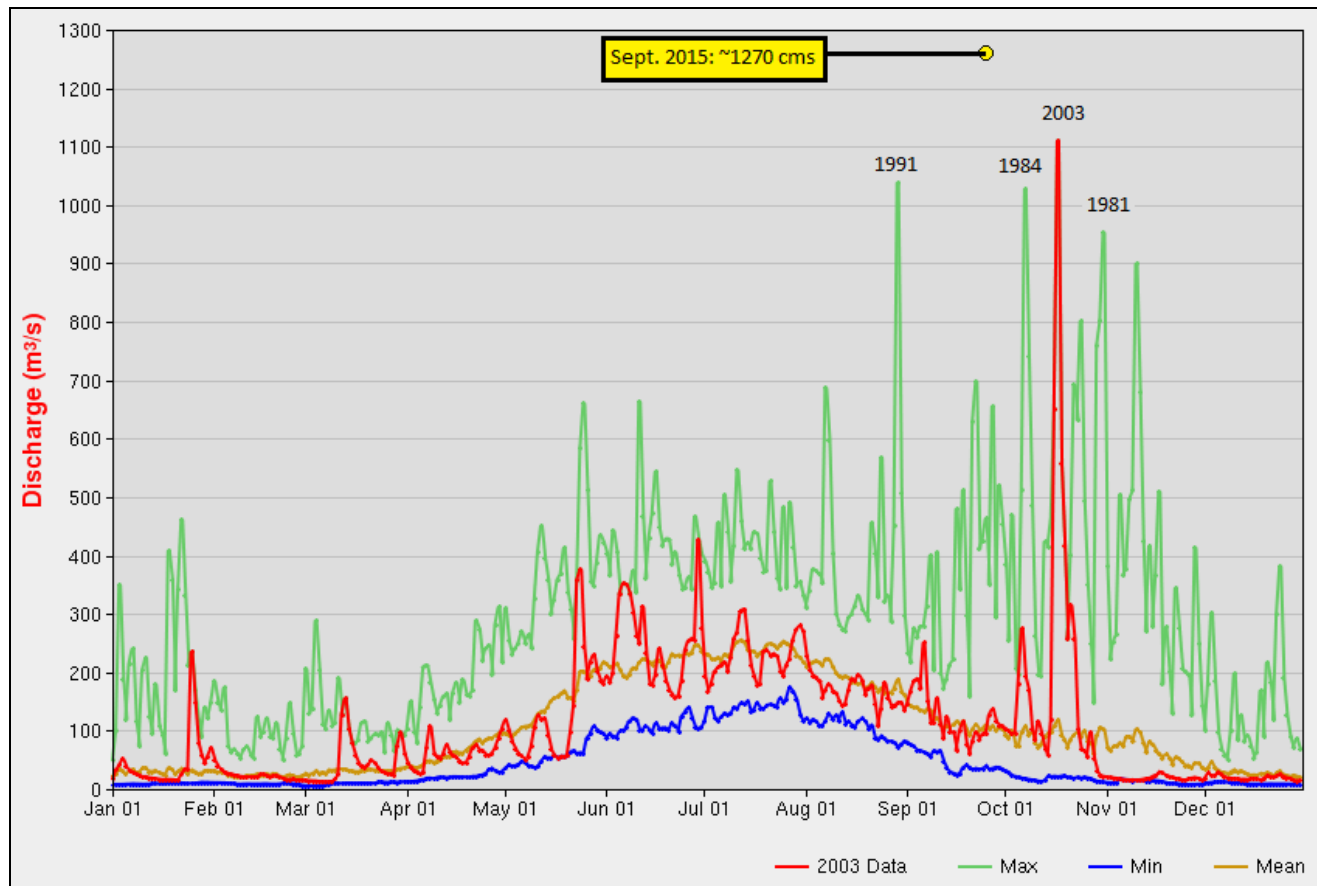
Figure 2: Historic data for the Elaho River from 1981 to 2012 summarizing the minimum (blue line), mean (brown), maximum (green), and 2012 (red) discharges. For reference, the September 2015 high flow event that triggered the berm breach on the Shovelnose is highlighted in yellow.

The magnitude of the event that occurred on September 20, 2015 was the sixth highest ever recorded (Figure 1) at the Brackendale water survey gauge dating back more than 90 years but was the highest recorded discharge (Figure 2) on the Elaho dating back 34 years. The Squamish FSR also

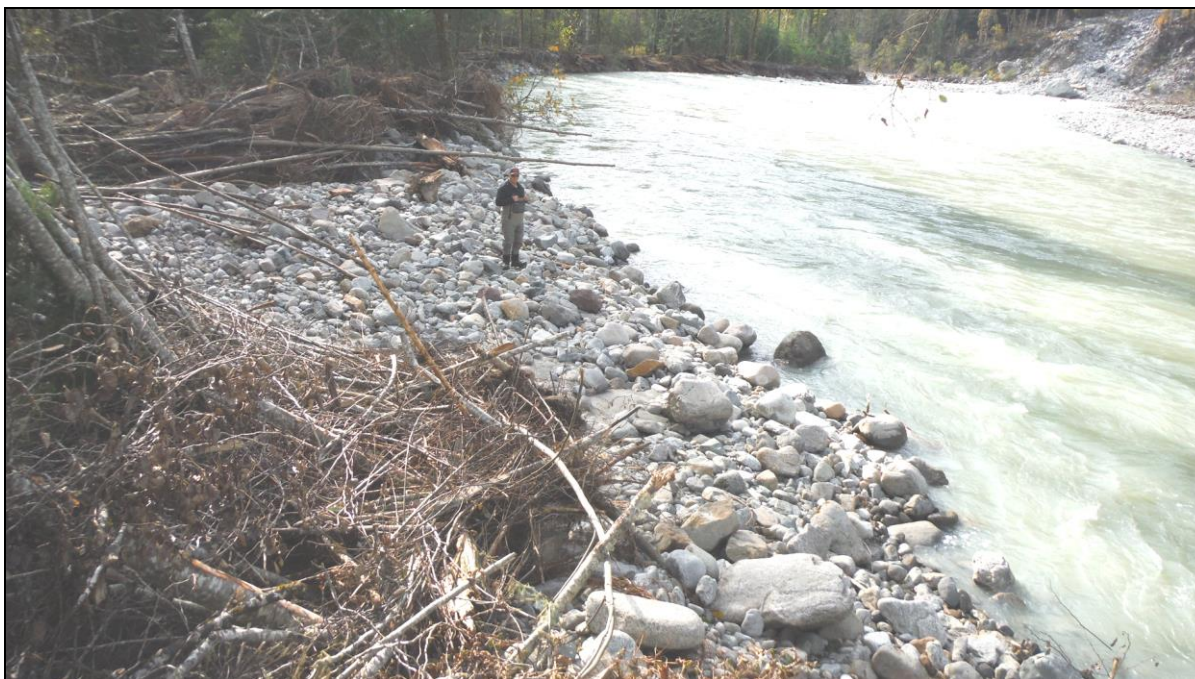
Figure 3: Looking downstream on the Squamish River mainstem showing the gap (exposed rocks) remaining after the high water event over-topped the gravel berm (out of photo to the left).

Based on the evidence observed, a significant portion of the flow breached the dyke and began running down through the upstream-most groundwater channel and down the mainstem of the restored reach of Shovelnose Creek. It is evident that the river will routinely breach the dyke in each subsequent high flow event. Over time the bank integrity will continue to unravel, and without corrective action, there is a high likelihood that the entire Squamish River mainstem could be forced through this location. This would be disastrous for the downstream complex; many of you are intimately familiar with the power of the Squamish River.

- The water that inundated the off-channel complex from the Squamish was a very large event.
- Portions of the berm have eroded away but will still be able to protect the channel downstream in future medium-high discharge events.

- Minor additions to the berm in its current location will be undertaken as a first line of defense.
- Building a larger berm a bit further downstream in the groundwater channel will act to be the major defense against significantly high discharge events now and also into the future. Simply augmenting the berm in its current location will not protect the channel should the Squamish mainstem find a route around the existing berm location.

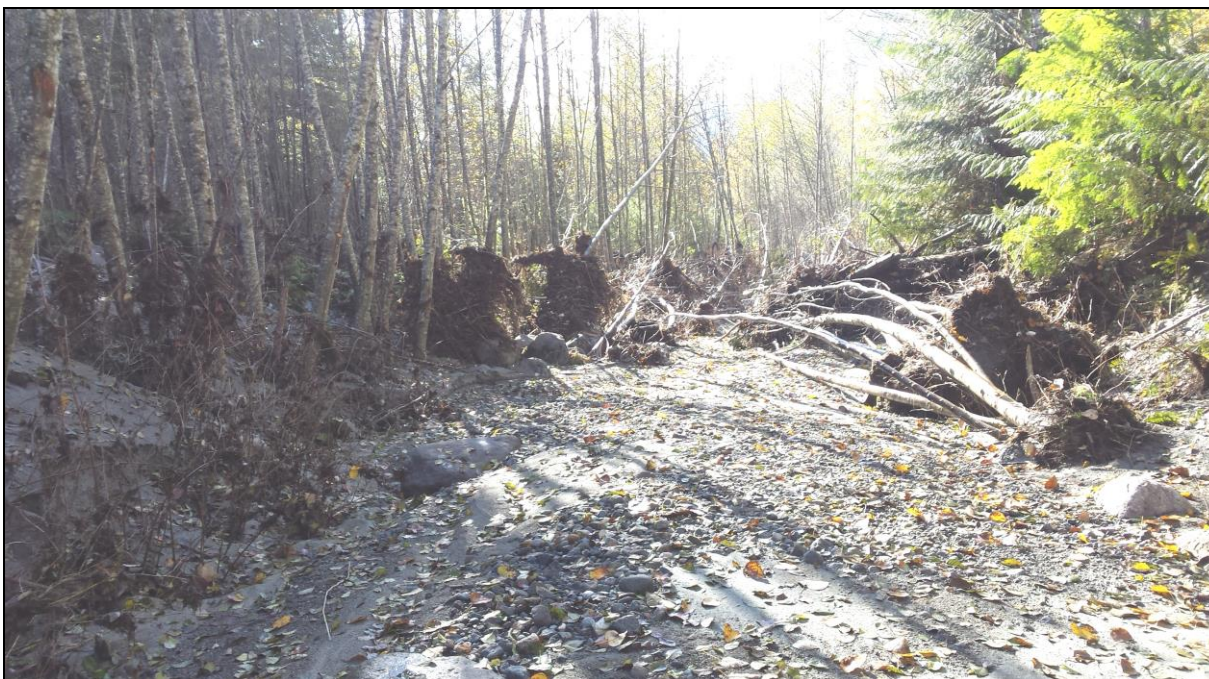
Figure 4: Looking downstream of the berm showing the damage caused when heightened flows from the Squamish River mainstem overtopped the protective berm built in 1994. Despite many trees being pushed over and fine sediment accumulating in depositional areas, the channel survived relatively well with no significant structural weaknesses observed.

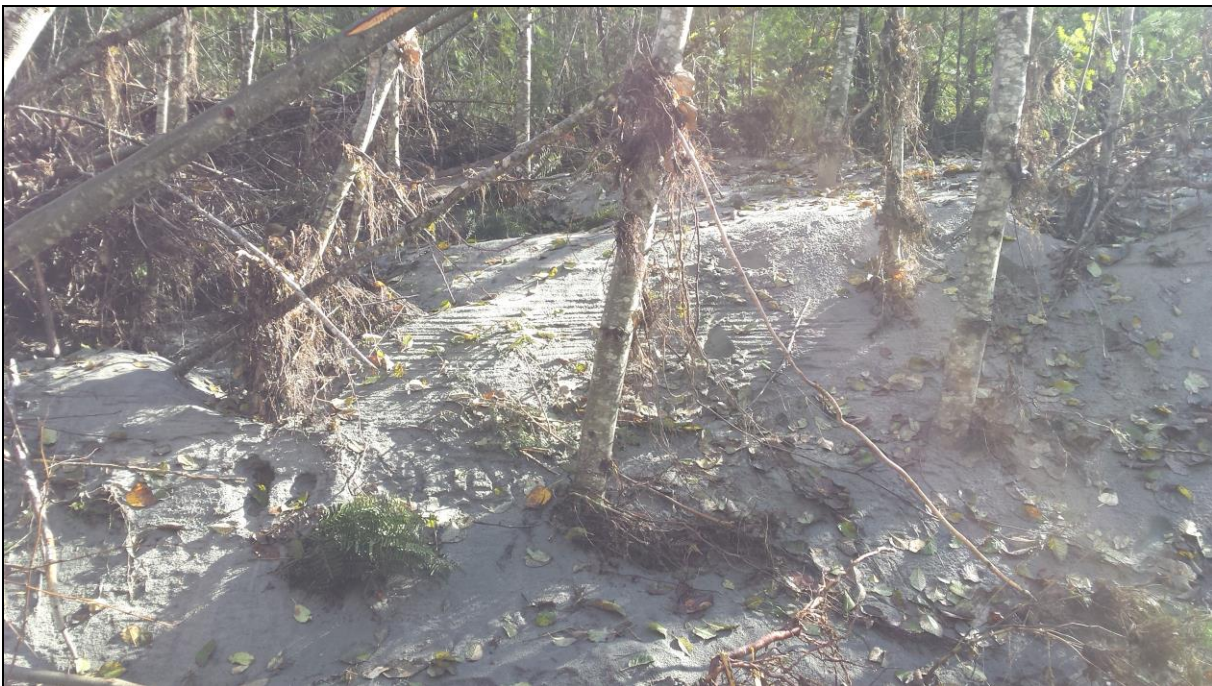
Figure 6: Photo of the 'layered' effect left behind in the fine sediments that were deposited along the banks of the off-channel indicate that the water receded very rapidly.

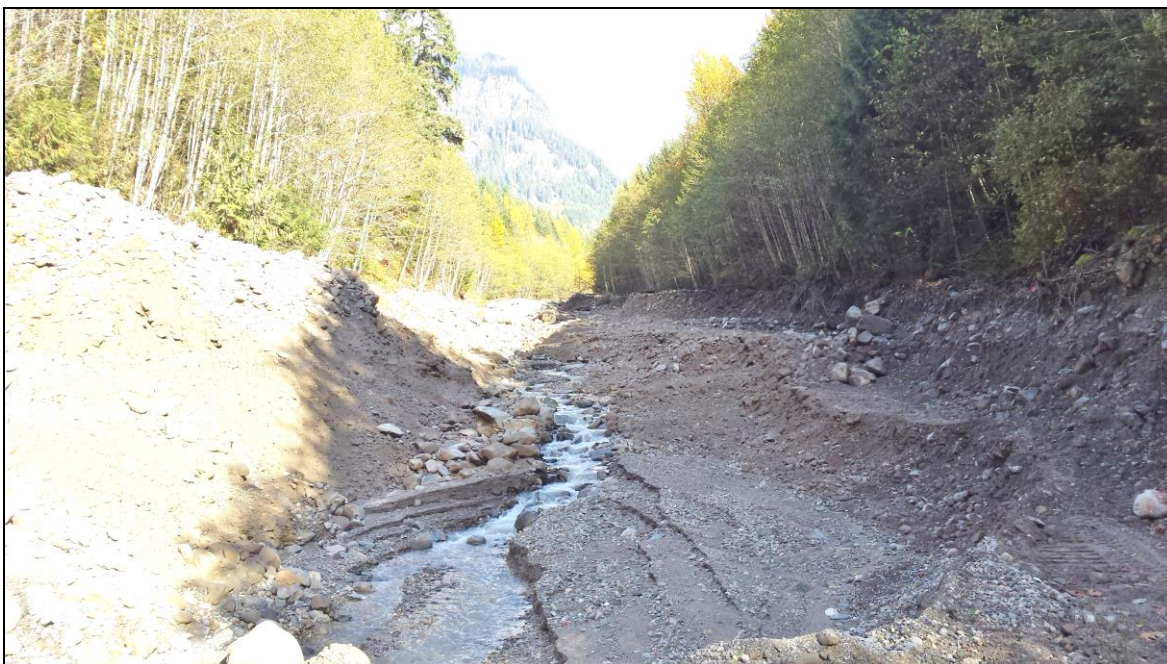
After conducting the site tour of the damaged berm and Shovelnose off-channel complex, we headed up the Squamish FSR to check on the large tributaries coming off Mount Cayley. Here we pieced together the final pieces in understanding why the berm at the Shovelnose had been breached (Figures 7 and 8). At some point during the high discharge event, there was a massive debris torrent from Turbid Creek. Not only did it take out the culvert and road, but it shot across the Squamish River mainstem, blocking and backwatering the river for an undetermined length of time until it eventually broke over the top. Once the backwatered flow on the Squamish broke through, the debris blockage likely unraveled quickly and the resulting surge of water rushed down the mainstem and over-topped the berm at Shovelnose. This scenario also explains why the fine sediment in the off-channel complex was deposited and why the 'layered' effect is present; the water came up quickly and receded quickly.

Figure 7: Photo looking upstream from the repaired road crossing where Turbid Creek took out the culvert and road in a significant earth-moving, debris torrent. Some of the bigger rocks transported in the event exceeded 6 feet in diameter. Photo taken after much debris had already been removed with an excavator.
